**Flood Control Project Maintenance
Levee Inspections**
LMA District Cover Sheet
Spring 2018 Levee Inspection Results

Plumas County

Levee Inspection Report By Mile - Spring 2018

Waterway	Bank	Unit Miles	Inspection Start/End	Inspector
Unit No. 01 North Fork Feather River	Left	1.89	04/26/2018 04/26/2018	Bob Duffey

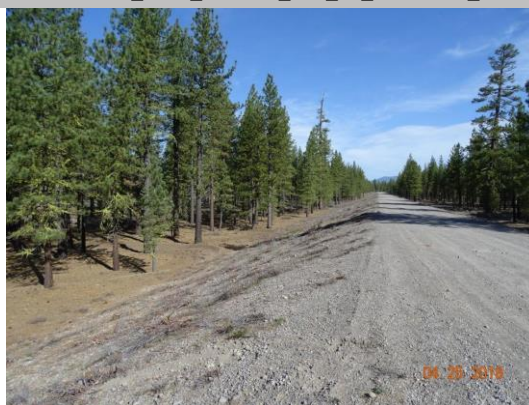
Photo 1 of 2 : SP_2018_NA0015_337_12_20180501_00019.jpg

LM Start	0.00	Rating **	A	Issue No.	12
LM End	0.78	Issue Type +	Ma	Location *	WS
Category	Earthen Levee			GPS Latitude/Longitude	
				Start	End
Item	Vegetation			40.273168 °	40.282842 °
				-121.244783 °	-121.251338 °
DWR ID	DWR_NA0015_01_f_2015_12				
Comment Code					
V2 : Remove the wild growth other than native grasses from the levee slopes.					
Inspector Comment					
The small pine trees and other vegetation was removed from the levee slope.

View of the removed pine trees and other vegetation from the waterside slope.

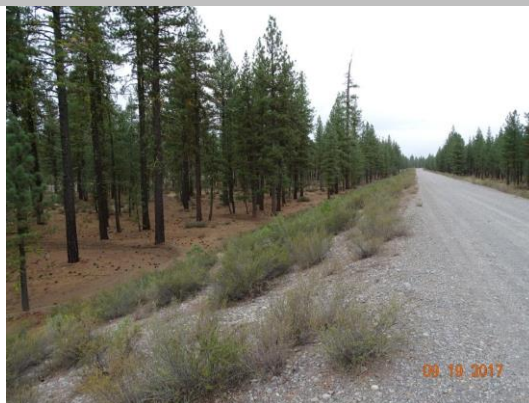
Photo 2 of 2 : SP_2018_NA0015_337_12_20180305_00009.jpg

View of the small pine trees and other vegetation on the waterside slope.

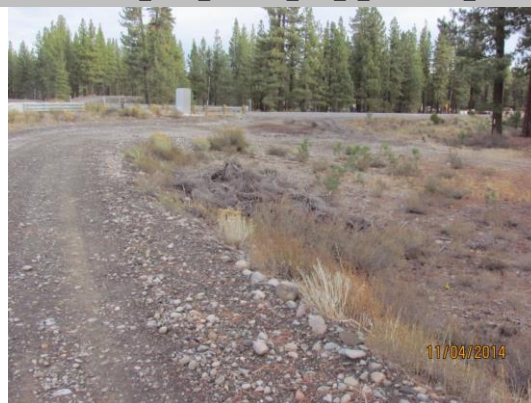
Photo 1 of 1 : SP_2018_NA0015_337_4_20180305_00001.jpg

LM Start	0.68	Rating **	M	Issue No.	4
LM End	0.68	Issue Type +	Ma	Location *	LS
Category	Earthen Levee			GPS Latitude/Longitude	
				Start	End
Item	Encroachments			40.281480 °	40.281480 °
				-121.250928 °	-121.250928 °
DWR ID	DWR_NA0015_01_s _ 2013_4				
Comment Code					
PR : Prunings					
Inspector Comment

View of the prunings along the landside slope.

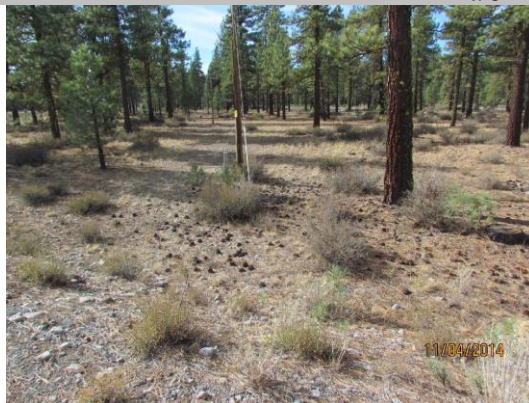
Photo 1 of 3 : UCIP_SP_2018_42643_72981.jpg

LM Start	0.77	Rating **	M	Issue No.	20
LM End	0.77	Issue Type +	En	Location *	
Category	Supplemental			GPS Latitude/Longitude	
				Start	End
Item	DWR UCIP Field Study			40.282683 °	40.282683 °
				-121.251453 °	-121.251453 °
DWR ID					
Comment Code					
Inspector Comment					
FS_ID:42643					
DS_ID:23039					
EP_NO: N/A					
Repair Type: Non-Urgent					
Crossing Status: Indicator Found					
UCIP Comments: Need to contact owner to determine additional information about crossing. Need depth of conduit and permit issued.					
FIELD_STRUCT_DESC: Telephone cable of an unknown size or material through the levee and across the channel, at an unknown depth. [Additional Reference(s): DWR Levee Log, 2005].					
FS Date: 11/4/2014

View of conduit pole located on landward side. Photo taken from right bank.

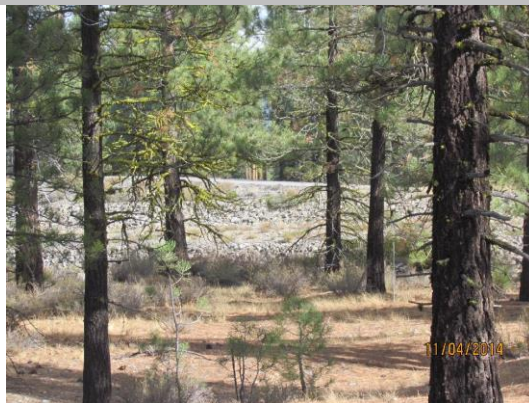
Photo 2 of 3 : UCIP_SP_2018_42643_72980.jpg

View of landward slope.

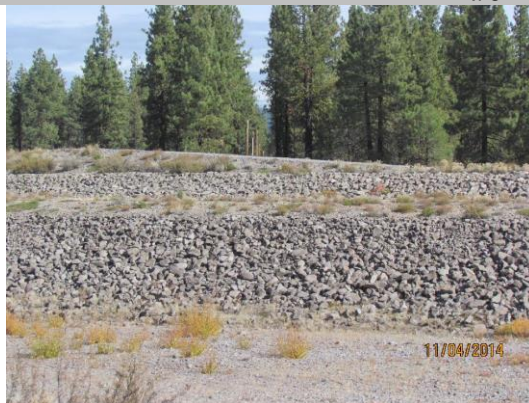
Photo 3 of 3 : UCIP_SP_2018_42643_72982.jpg

View of levee, ramp, and posts visible between trees.

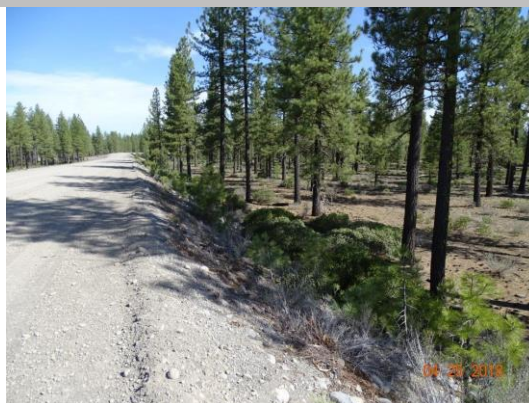
Photo 1 of 1 : SP_2018_NA0015_337_18_20180501_00027.jpg

LM Start	0.79	Rating **	M	Issue No.	18
LM End	1.88	Issue Type +	Ma	Location *	LS
Category	Earthen Levee			GPS Latitude/Longitude	
				Start	End
Item	Vegetation			40.282962 °	40.297068 °
				-121.251307 °	-121.257120 °
DWR ID	DWR_NA0015_01_s_2018_18				
Comment Code					
V2 : Remove the wild growth other than native grasses from the levee slopes.					
Inspector Comment					
Remove the small pine trees and vegetation from the landside slope.

View of the small pine trees and vegetation along the landside slope.

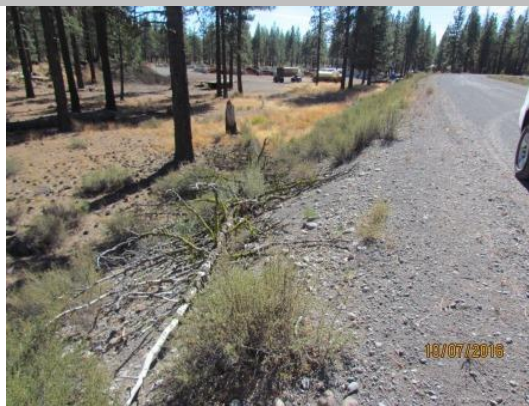
Photo 1 of 1 : SP_2018_NA0015_337_13_20180305_00010.jpg

LM Start	0.88	Rating **	M	Issue No.	13
LM End	0.88	Issue Type +	En	Location *	LS
Category	Earthen Levee			GPS Latitude/Longitude	
				Start	End
Item	Encroachments			40.284309 °	40.284309 °
				-121.251541 °	-121.251541 °
DWR ID	DWR_NA0015_01_f_2016_13				
Comment Code					
TR : Tree or limb					
Inspector Comment					
Remove the fallen tree from the levee slope.

View of the fallen tree on the landside slope.

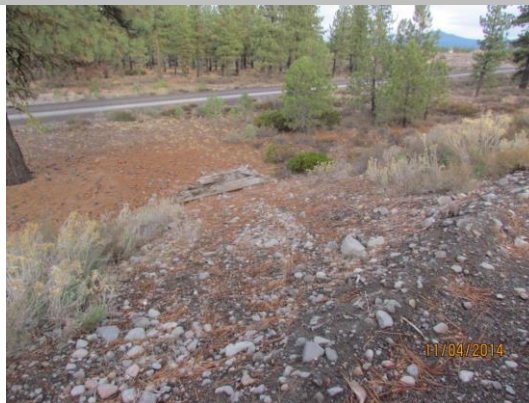
Photo 1 of 1 : SP_2018_NA0015_337_5_20180305_00002.jpg

LM Start	0.96	Rating **	A/W	Issue No.	5
LM End	0.96	Issue Type +	Ma	Location *	WS
Category	Earthen Levee			GPS Latitude/Longitude	
				Start	End
Item	Slope Stability			40.285363 °	40.285363 °
				-121.251973 °	-121.251973 °
DWR ID	DWR_NA0015_01_f_2013_5				
Comment Code					
S3 : Repair the levee slope damaged by vehicle traffic and prevent access where possible.					
Inspector Comment

View of the vehicle erosion along the waterside slope.

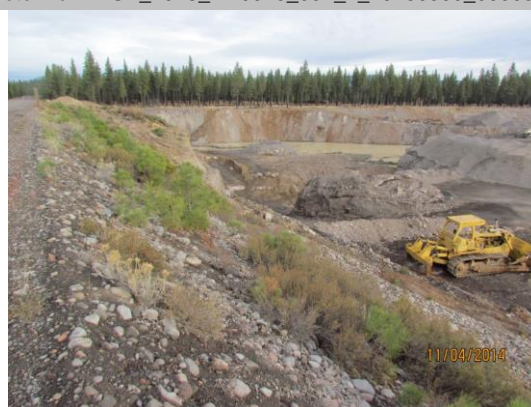
Photo 1 of 2 : SP_2018_NA0015_337_7_20180305_00003.jpg

LM Start	1.41	Rating **	U	Issue No.	7
LM End	1.50	Issue Type +	En	Location *	LS
Category	Earthen Levee			GPS Latitude/Longitude	
				Start	End
Item	Encroachments			40.290758 °	40.291987 °
				-121.255402 °	-121.256072 °
DWR ID	DWR_NA0015_01_f_2014_7				
Comment Code					
MA : Material					
Inspector Comment					
The landowner needs to replace the material that has been removed from the toe of the levee.

View of the area where the contractor has removed the material from toe of the levee.

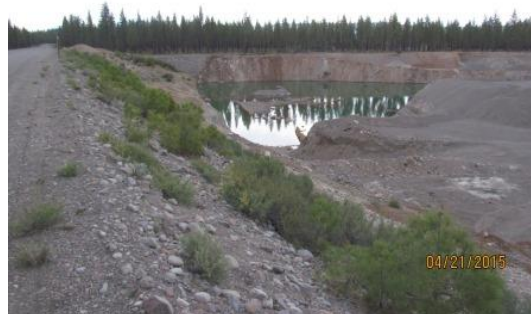
Photo 2 of 2 : SP_2018_NA0015_337_7_20180305_00004.jpg

View of the area where the contractor has removed the material from toe of the levee.

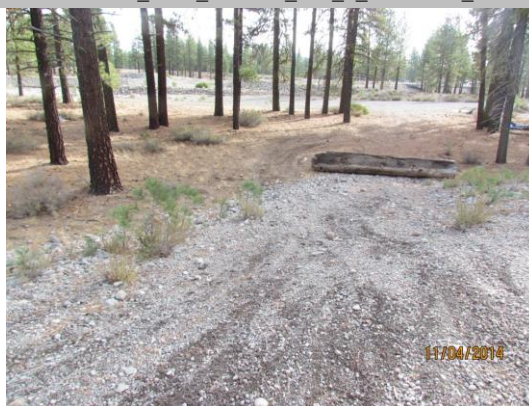
Photo 1 of 2 : SP_2018_NA0015_338_6_20180305_00005.jpg

LM Start	0.46	Rating **	M	Issue No.	6
LM End	0.46	Issue Type +	Ma	Location *	WS
Category	Earthen Levee			GPS Latitude/Longitude	
				Start	End
Item	Slope Stability			40.283059 °	40.283059 °
				-121.253989 °	-121.253989 °
DWR ID	DWR_NA0015_02_f_2013_6				
Comment Code					
S3 : Repair the levee slope damaged by vehicle traffic and prevent access where possible.					
Inspector Comment

View of the vehicle erosion on the landside slope.

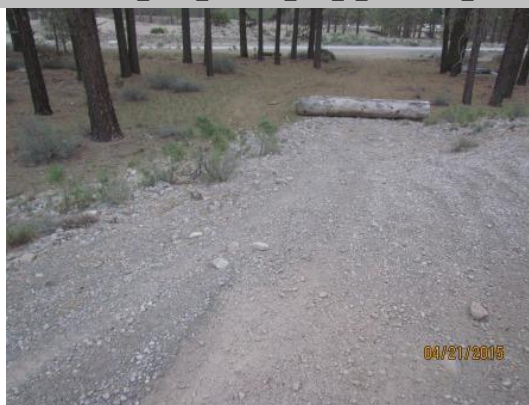
Photo 2 of 2 : SP_2018_NA0015_338_6_20180305_00006.jpg

View of the vehicle erosion on the waterside slope.

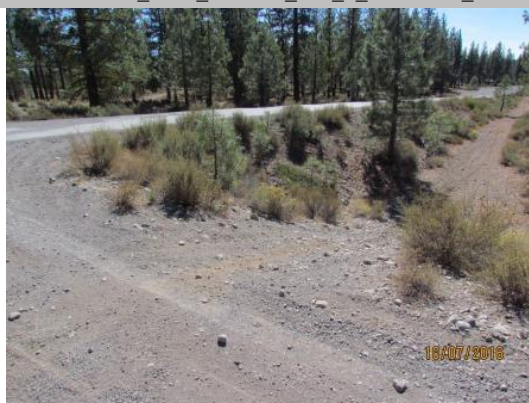
Photo 1 of 1 : SP_2018_NA0015_338_4_20180305_00003.jpg

LM Start	0.55	Rating **	M	Issue No.	4
LM End	0.55	Issue Type +	Ma	Location *	LS
Category	Earthen Levee			GPS Latitude/Longitude	
				Start	End
Item	Slope Stability			40.281950 °	121.253710 °
				40.281950 °	121.253710 °
DWR ID	DWR_NA0015_02_s_2012_4				
Comment Code					
S3 : Repair the levee slope damaged by vehicle traffic and prevent access where possible.					
Inspector Comment

View of the slope instability cause by vehicle along the landside slope.

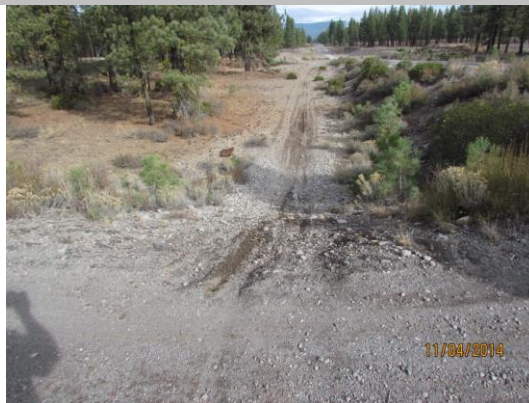
Photo 1 of 1 : SP_2018_NA0015_338_5_20180305_00004.jpg

LM Start	0.55	Rating **	M	Issue No.	5
LM End	0.55	Issue Type +	Ma	Location *	WS
Category	Earthen Levee			GPS Latitude/Longitude	
				Start	End
Item	Slope Stability			40.281950 °	121.253710 °
				40.281950 °	121.253710 °
DWR ID	DWR_NA0015_02_s_2012_5				
Comment Code					
S3 : Repair the levee slope damaged by vehicle traffic and prevent access where possible.					
Inspector Comment

View of the vehicle erosion on the waterside slope.

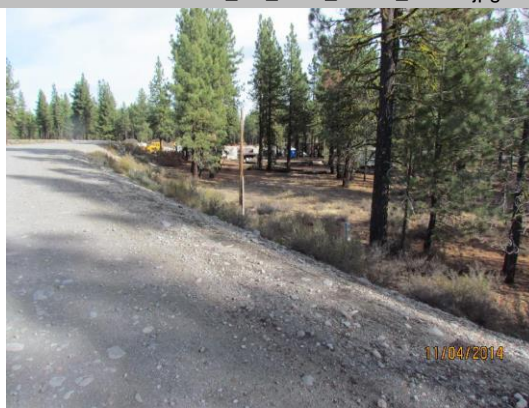
Photo 1 of 3 : UCIP_SP_2018_42644_72984.jpg

LM Start	0.66	Rating **	M	Issue No.	10	
LM End	0.66	Issue Type +	En	Location *		
Category	Supplemental			GPS Latitude/Longitude		
				Start	End	
Item	DWR UCIP Field Study			40.280737 °	40.280737 °	
				-121.252512 °	-121.252512 °	
DWR ID						
Comment Code						
Inspector Comment						
FS_ID:42644						
DS_ID:23040						
EP_NO: N/A						
Repair Type: Non-Urgent						
Crossing Status: Indicator Found						
UCIP Comments: Need to contact owner to determine additional information about crossing. Need depth of conduit and permit issued.						
FIELD_STRUCT_DESC: Telephone cable of an unknown size or material through the levee and across the channel, at an unknown depth. [Additional Reference(s): DWR Levee Log, 2005].						
FS Date: 11/4/2014

View of landward side conduit pole located at landward toe. Photo taken from the left bank.

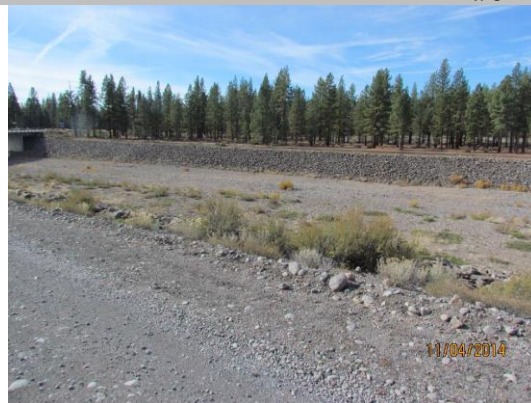
Photo 2 of 3 : UCIP_SP_2018_42644_72983.jpg

View of waterward side.

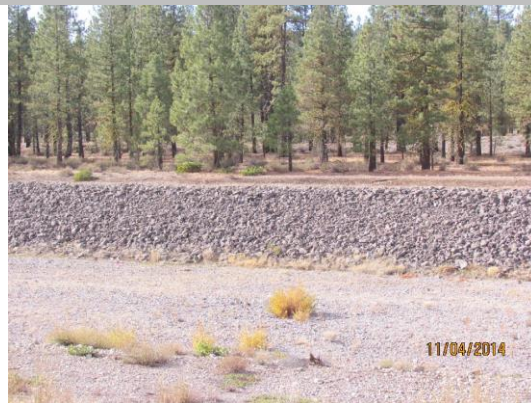
Photo 3 of 3 : UCIP_SP_2018_42644_72985.jpg

View of opposite bank.

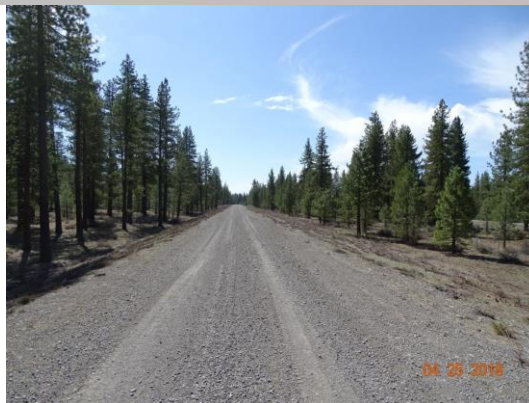
Photo 1 of 1 : SP_2018_NA0015_338_7_20180501_00013.jpg

LM Start	0.71	Rating **	A	Issue No.	7
LM End	1.36	Issue Type +	Ma	Location *	LS
Category	Earthen Levee			GPS Latitude/Longitude	
				Start	End
Item	Vegetation			40.279948 °	40.271748 °
				-121.252118 °	-121.246737 °
DWR ID	DWR_NA0015_02_s _ 2018_7				
Comment Code					
V2 : Remove the wild growth other than native grasses from the levee slopes.					
Inspector Comment					
Small pine trees was removed from the landside slope.

View of the removed small pine trees from the landside slope.
